**Collision Between Two Washington Metropolitan Area  
Transit Authority Trains at the Woodley Park-  
Zoo/Adams Morgan Station in Washington, D.C.  
November 3, 2004**

**NTSB/RAR-06/01**

**NTSB/RAR-06/01  
PB2006-916301  
Notation 7680D  
Adopted March 23, 2006**

**Abstract:** On Wednesday, November 3, 2004, about 12:49 p.m., eastern standard time, Washington Metropolitan Area Transit Authority Metrorail train 703 collided with train 105 at the Woodley Park-Zoo/Adams Morgan station in Washington, D.C. Train 703 was traveling outbound on the Red-Line segment of the Metrorail system and ascending the grade between the Woodley Park-Zoo/Adams Morgan and the Cleveland Park underground stations, when it rolled backwards about 2,246 feet and struck train 105 at a speed of about 36 mph. Train 703 was operating as a nonrevenue train; that is, it was not carrying passengers. Train 105, a revenue train, was in the process of discharging and loading passengers at the Woodley Park-Zoo/Adams Morgan station. There were about 70 passengers on board train 105. Some passengers had exited the train just before or during the collision. The District of Columbia Fire and Emergency Medical Service tr

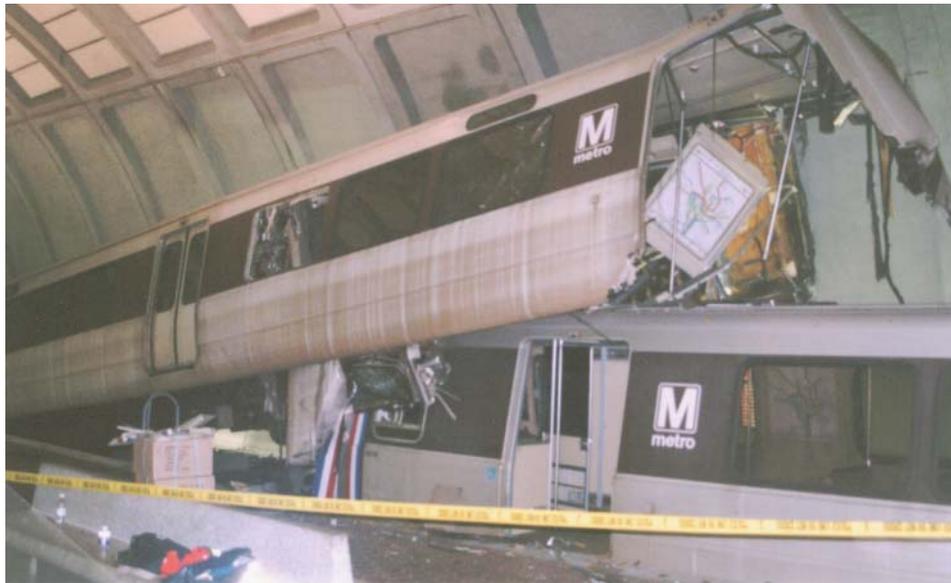
**Figure 2.** Train 703 resting on top of train 105.

The rear end of the last car (1077) of northbound nonrevenue train 703 collided with the forward end of the first car (4018) of revenue train 105, which had stopped to service the Woodley Park station. The front end of car 4018 came to rest beneath, and substantially inside of, the breached rear carbody shell of 1077. Although almost all of the cars in both trains sustained damage, car 1077 bore the majority of the collision damage.

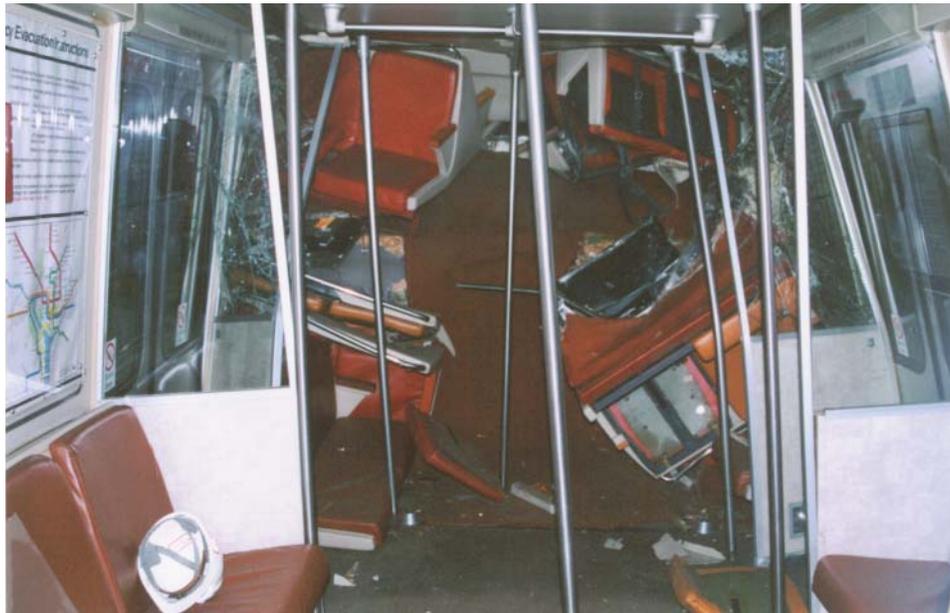
The collision wreckage was confined to about 100 feet of track immediately adjacent to the station platform. Small elements of collision debris were also found resting on the platform near the wreckage, having apparently separated from the wreckage during the collision.<sup>29</sup> The two entangled carbodies came to rest upright and remained substantially aligned with the track, although elements of the two carbodies were wedged against the track-side of the platform and also on the opposite side, against the wall. There was no evidence of fire.

**Figure 4.** Collision end of car 1077 showing debris field.

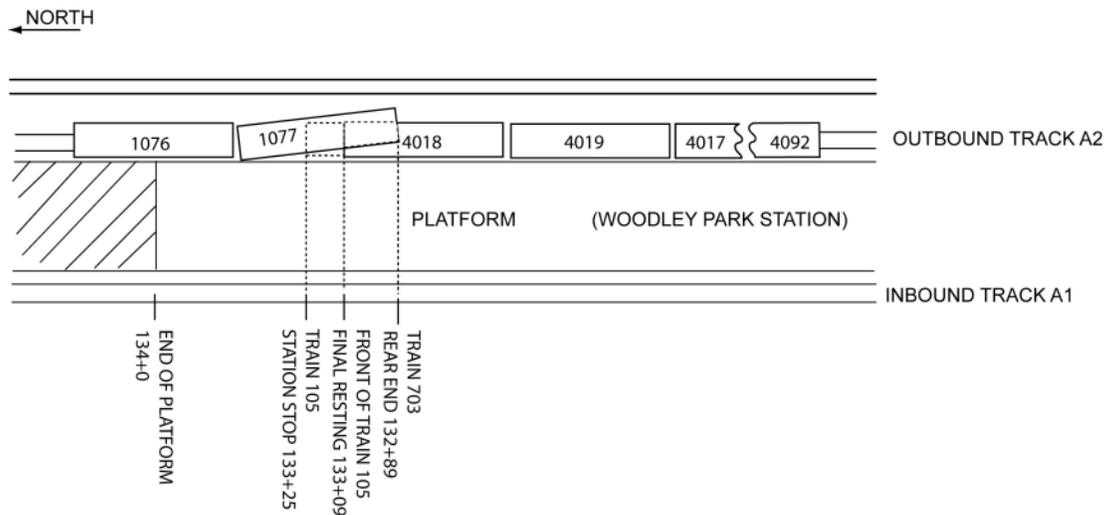
The point of collision was determined to be about 75 feet south of the north end of the passenger platform. The impact shoved train 105 rearward about 16 feet, relative to where it had initially stopped. Car 1077, at the rear end of train 703, longitudinally overrode the leading end of the first car (4018) of the revenue train by about 20 feet. Car 1077 also sustained a loss of about 34 linear feet of the passenger occupant volume (survival space), which is almost half the length of the passenger compartment. The 34-foot loss of space (the collision intrusion) consisted of a tightly compressed mass of dislodged and displaced crushed seats, floor, ceiling, other interior elements, and the rear bulkhead panel structure. (See figure 4.) The rear end of car 1077 was lifted, and its roof came to rest about 18.8 feet above the top of rail with about a 10° upward incline and about a 4° cross level lean to the left toward the platform. (See figure 5.)

**Figure 5.** Accident site plan.

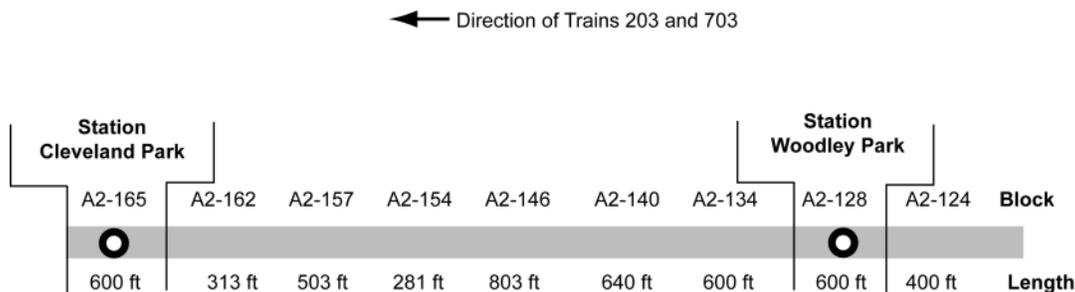
The data indicated that train 203 had entered track circuit A2-165 at Cleveland Park station about 12:45:28 p.m. (See figure 7 for block layout between Woodley Park and Cleveland Park stations.) At the same time, train 703 was entering track circuit A2-124 (moving at 34.1 mph), which was about 3,827 feet from the beginning of track circuit A2-165. About 12:46:38 p.m., train 203 left track circuit A2-165. At that time, train 703 was transiting circuit A2-146, about 1,097 feet from the beginning of track circuit A2-165. The data then indicated that about 12:46:41 p.m., train 703 would have received a 50 mph ATP regulated speed authority when it entered track circuit A2-154. About 12:46:47 p.m., train 703 was in track circuit A2-157. At this time, train 203 was still occupying track circuit A2-171. According to interpretations by WMATA officials, train 703 received a “reduced 28 mph ATP speed with Train 203 occupying A2-171 circuit,” and “train 703 would have received an over speed alarm.” In addition, about 12:46:51 p.m., as train 203 left track circuit A2-171, train 703 would have received a 55 mph ATP regulated speed authority. Train 703 traveled into track circuit A2-162 about 12:47:03 p.m. This was the farthest point train 703 traveled on November 3. Because train 203 had left track circuit A2-181, train 703 would have received a 50 mph ATP regulated speed authority.

**Figure 7.** Block identification and length for A2 track outbound on Red Line.

The data then indicated that at least part of train 703 had occupied track circuit A2-162 for about 30 seconds. About 12:47:33 p.m., train 703 was recorded as leaving track circuit A2-162 moving in the reverse direction (negative speed recorded). Train 703 was recorded as exiting track circuit A2-140 with a train speed of 36 mph. This is the last recorded data before train 703 collided with train 105. The estimated total distance train 703 traveled backwards to the collision with train 105 at Woodley Park station was about 2,246 feet.
