**Collision Between Two Washington Metropolitan Area  
Transit Authority Trains at the Woodley Park-  
Zoo/Adams Morgan Station in Washington, D.C.  
November 3, 2004**

**NTSB/RAR-06/01**

**NTSB/RAR-06/01  
PB2006-916301  
Notation 7680D  
Adopted March 23, 2006**

**Abstract:** On Wednesday, November 3, 2004, about 12:49 p.m., eastern standard time, Washington Metropolitan Area Transit Authority Metrorail train 703 collided with train 105 at the Woodley Park-Zoo/Adams Morgan station in Washington, D.C. Train 703 was traveling outbound on the Red-Line segment of the Metrorail system and ascending the grade between the Woodley Park-Zoo/Adams Morgan and the Cleveland Park underground stations, when it rolled backwards about 2,246 feet and struck train 105 at a speed of about 36 mph. Train 703 was operating as a nonrevenue train; that is, it was not carrying passengers. Train 105, a revenue train, was in the process of discharging and loading passengers at the Woodley Park-Zoo/Adams Morgan station. There were about 70 passengers on board train 105. Some passengers had exited the train just before or during the collision. The District of Columbia Fire and Emergency Medical Service tr

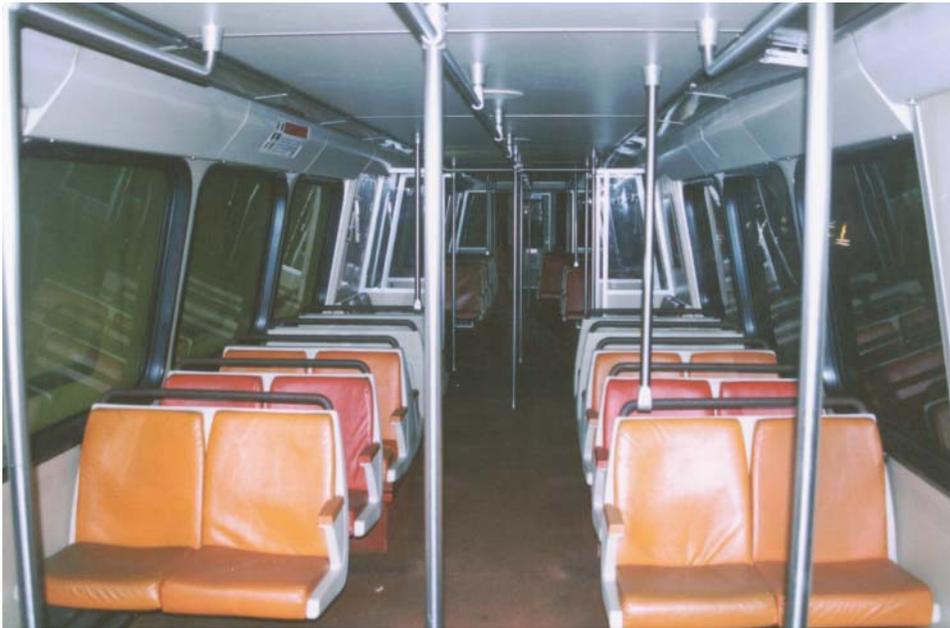
**Figure 3.** Postaccident photo of car 1076 (mate to car 1077), showing typical interior view of an undamaged car.

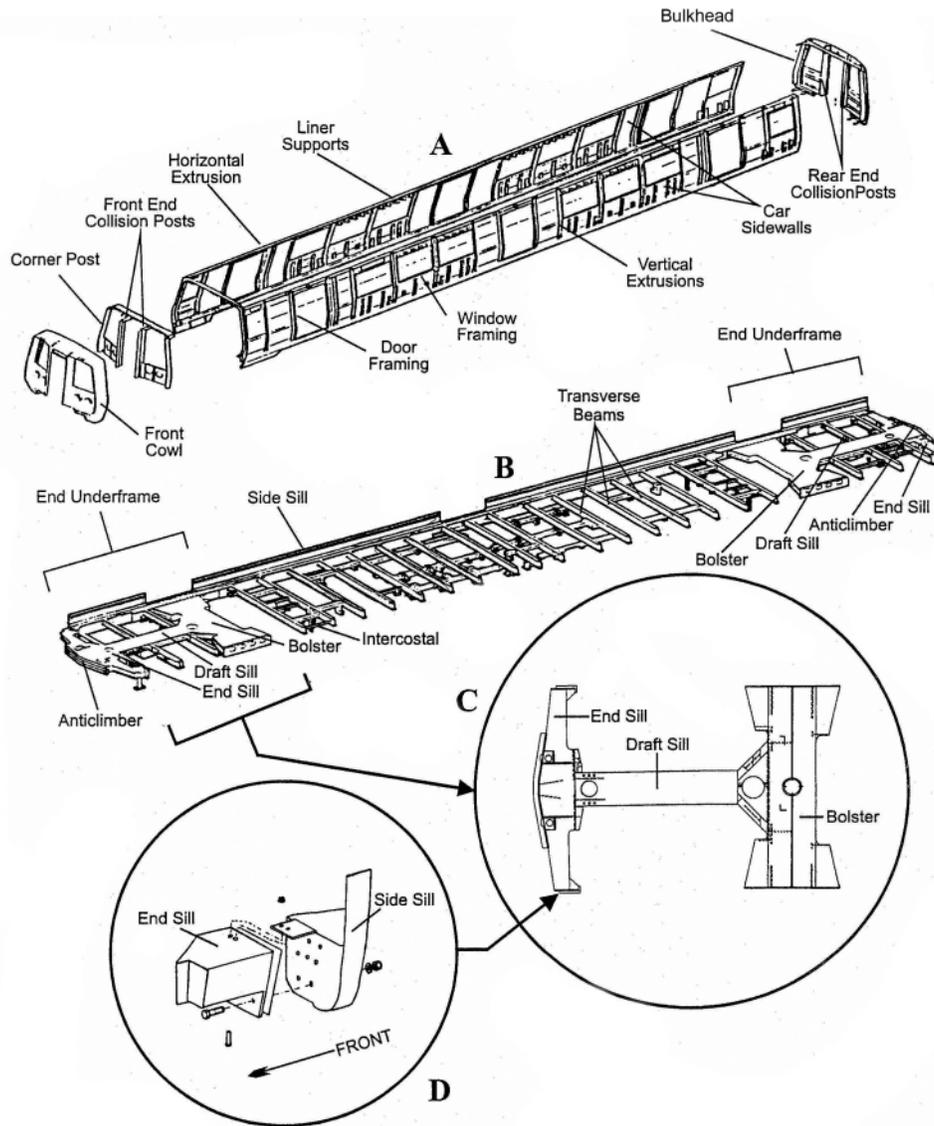
The main underframe of the 1000- and 4000-series cars consists of transverse aluminum beams attached by blind-fastener bolts to the aluminum lower sidewall (U-channel shaped) extrusions. These beams extend the full length of the carbody and function as side-sill components. The cars do not have a conventional center-sill element (as found in some intercity passenger car designs), but incorporate longitudinally oriented intercostal elements fitted between some of the transverse beams. The end underframe assemblies (one fitted to each end of the car with the truck-assemblies attached to them) are fabricated of low-alloy/high-tensile steel and consist of a body bolster, a draft sill, and an angular end-sill fitted with a conventional anti-climber element, all welded together to form a single-unit assembly. (See figure 6.)

**Figure 6.** <sup>a</sup>(A) Typical WMATA Metrorail carbody structure. (B) Underframe of Rohr Metrorail car. (C) End underframe assembly. (D) Attachment of side sill to end of underframe.

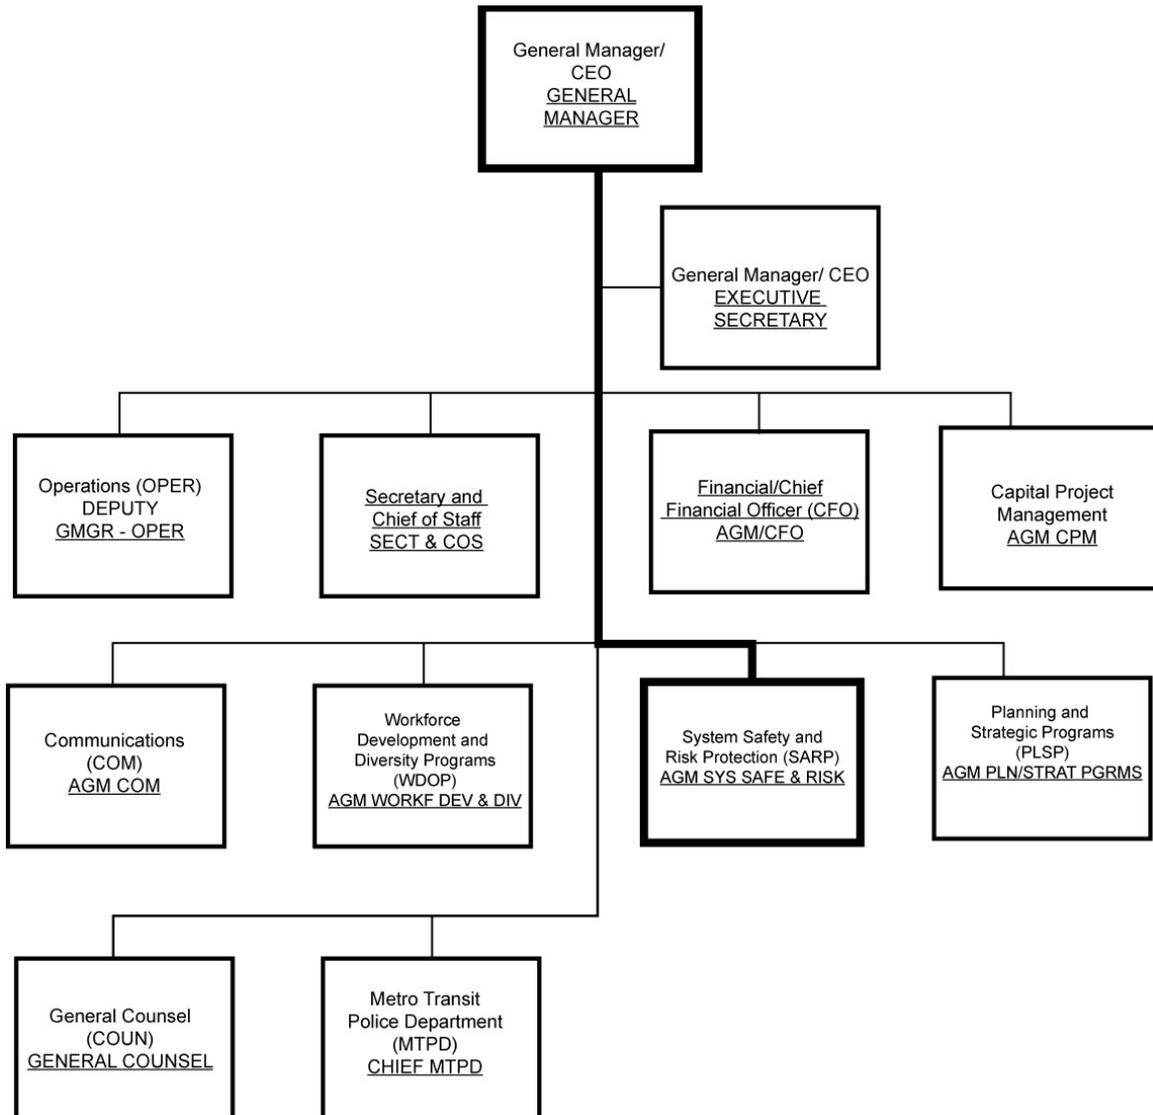
An organization chart provided by WMATA in 2004 showed that the safety department was still reporting directly to the GM when the November 3, 2004, accident occurred. (See figure 8.) However, after the accident, WMATA instituted a reorganization effective March 17, 2005, that rescinded the direct reporting link between the safety department and the GM. (See figure 9.)

Figure 8. WMATA’s organizational chart in effect on November 3, 2004.

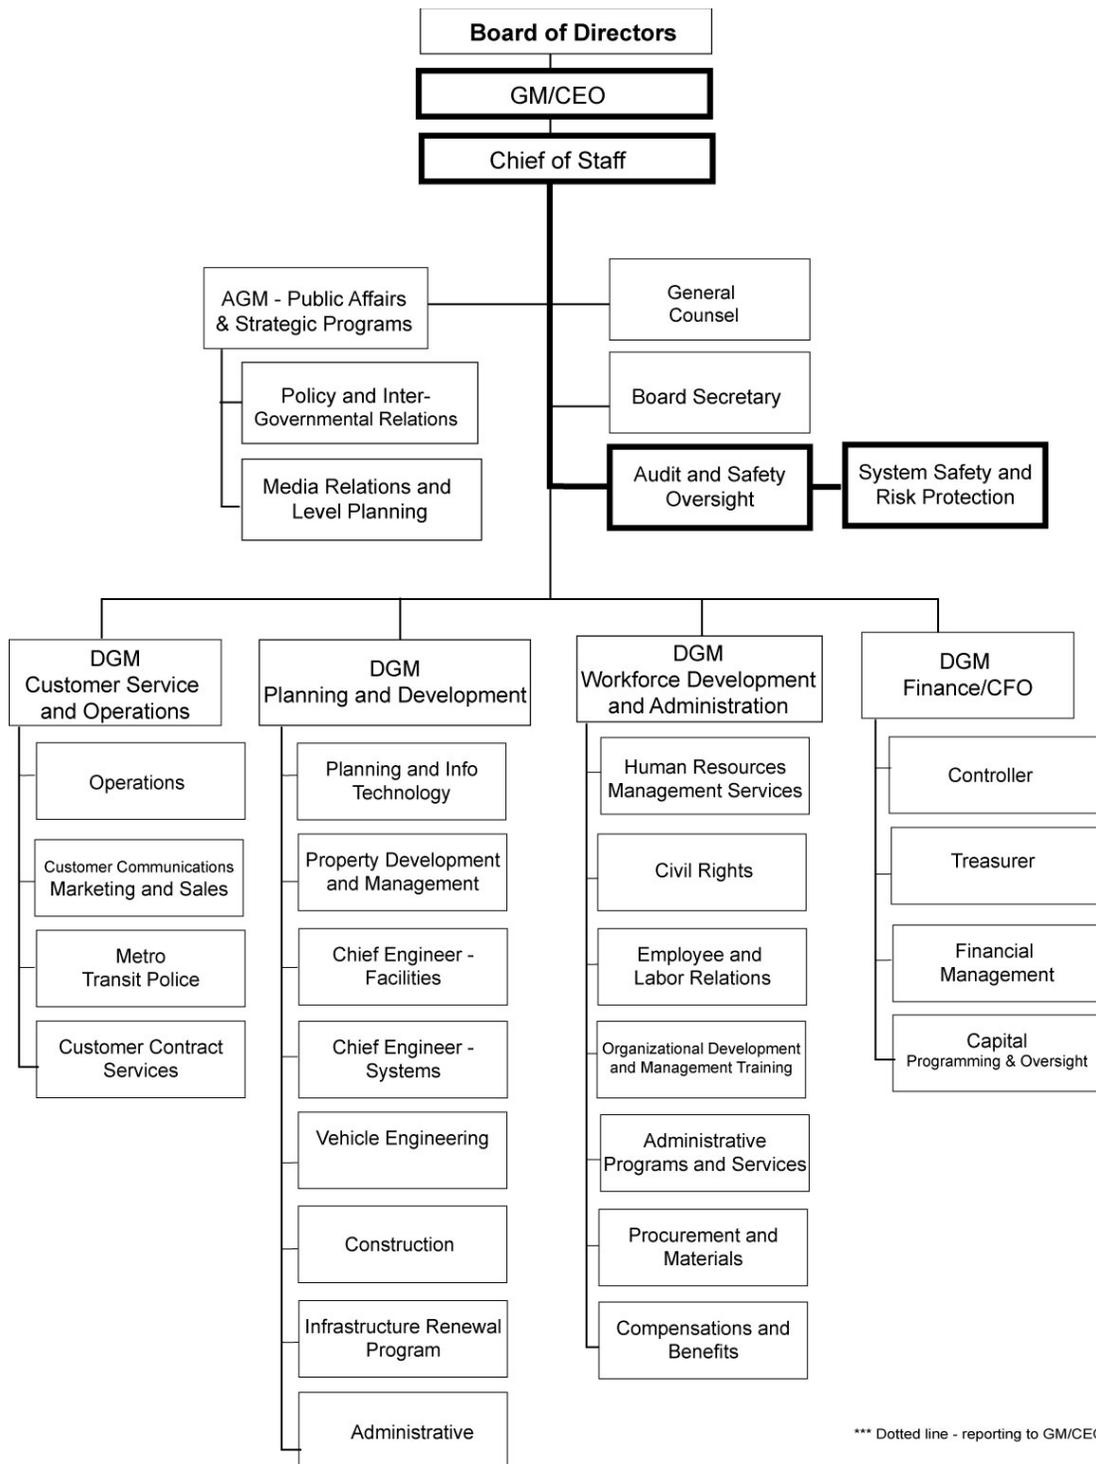
**Figure 9.** WMATA’s organizational chart reflecting the reorganization of its management structure after the November 3, 2004, accident.

In a letter to WMATA, dated March 31, 2005, the TOC expressed concern about the transit authority's reorganization, which eliminated the safety department's direct access to the GM. The GM responded to the TOC and explained that the postaccident change to WMATA's reporting structure would provide for:
